Sloan Flushometer™

PARTS LIST

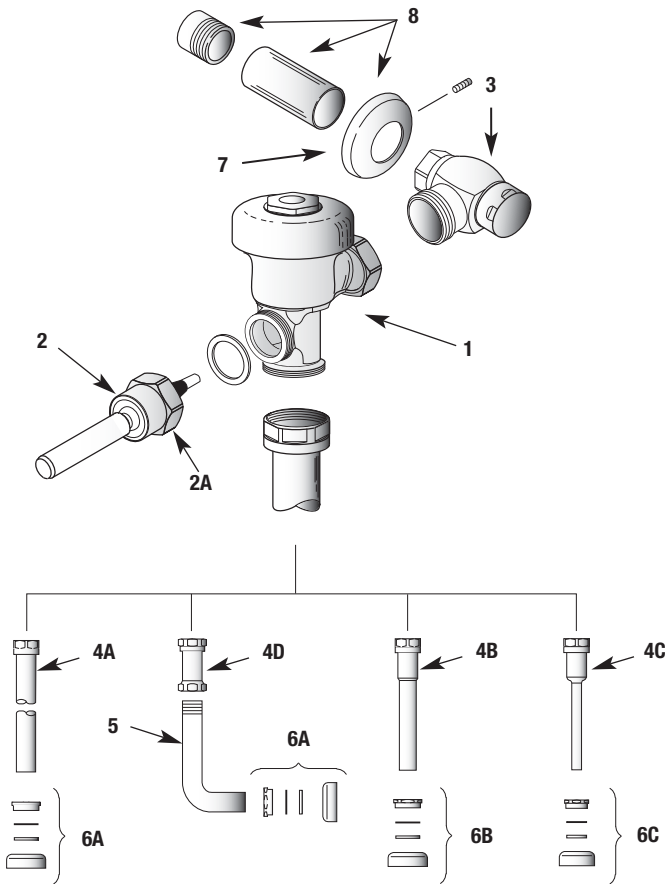
Item No.	Code No.	Part No.	Description
1.	—	A-3-A	Valve Assembly
2.	0302390	B-73-A	ADA Compliant Handle Assembly
2A.	0301082	A-6	CP Handle Coupling
3.	—	H-710-A	Bak-Chek® Control Stop – 3/4" or 1"
4A.	5323007	V-500-AA	1-1/2" (38 mm) x 9" (229 mm) Vacuum Breaker Assembly **
4B.	5323006	V-500-AA	1-1/4" (32 mm) x 9" (229 mm) Vacuum Breaker Assembly
4C.	5323005	V-500-AA	3/4" (19 mm) x 9" (229 mm) Vacuum Breaker Assembly
4D.	—	V-500-A	Vacuum Breaker Assembly

5.	0396293	F-109	1-1/2" (38 mm) Elbow Flush Connection
6A.	0306145	F-56-A	1-1/2" (38 mm) Spud Coupling Assembly
6B.	0306142	F-55-A	1-1/4" (32 mm) Spud Coupling Assembly
6C.	0306102	F-54-A	3/4" (19 mm) Spud Coupling Assembly

7.	—	F-7	Supply Flange (Supplied when Valve is not Ordered with Sweat Solder Kit)
8.	3308782	H-633-AA	1" (25 mm) Sweat Solder Kit with Cast Set Screw Flange
	3308788	H-636-AA	3/4" (19 mm) Sweat Solder Kit with Cast Set Screw Flange

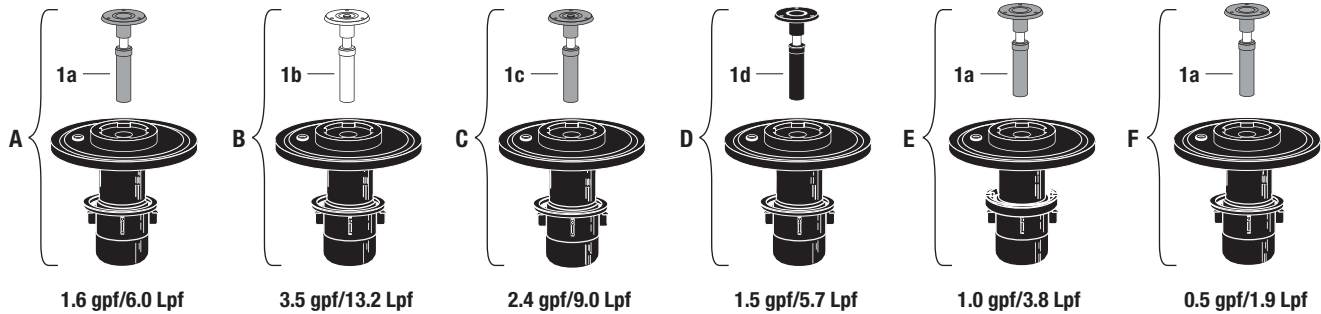
INSIDE COMPONENTS

Item No.	Code No.	Part No.	Description
1a.	5301211	A-19-ALC	Relief Valve, Green (Closet/Urinal-LC) – 12 per package
1b.	5301058	A-19-AC	Relief Valve, White (Closet) – 12 per package
1c.	0301143	A-19-AL	Relief Valve, Blue (9 Liter Closet) – 12 per package
1d.	5301059	A-19-AU	Relief Valve, Black (Urinal) – 12 per package
